Recall Notification

No. **010029**
October 2005

SUBJECT: Inspection of the fuel line to engine fuel rail connector

PROCEDURE FOR FUEL CONNECTOR INSPECTION – RECALL 010029

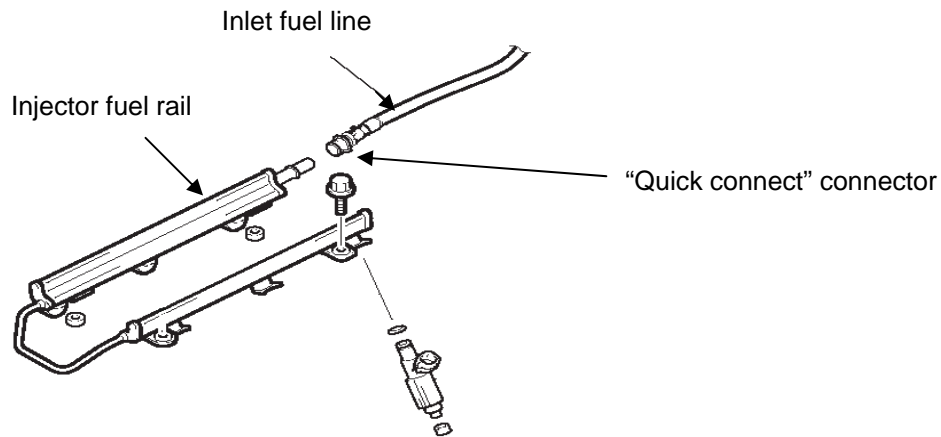
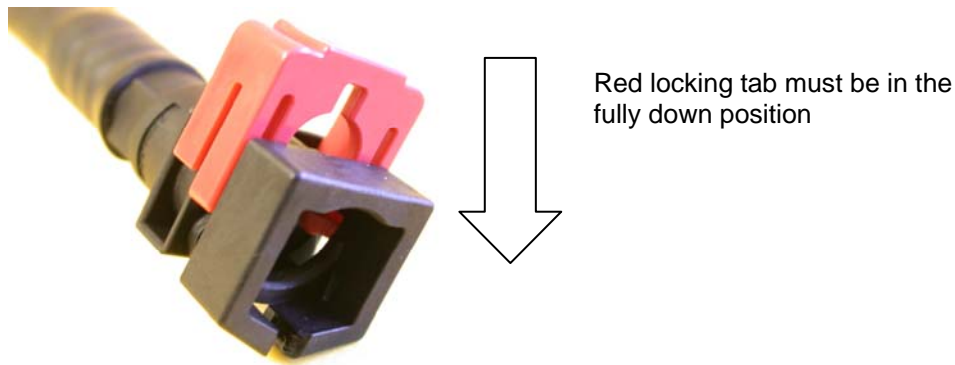
Location

The “quick connect” connector of the engine bay fuel line may not be correctly secured to the engine fuel rail and in the worst case may become dislodged causing the engine to cease operating.

The quick connect connector is attached to the end of the inlet fuel hose and is the coupling to the engine injector fuel rail. The red locking tab should be in the fully down position if the fuel connector is correctly located.

Inspect and confirm that the fuel line “quick connect” connector to the fuel rail is fully based and the red locking tab is secured in the fully down position.

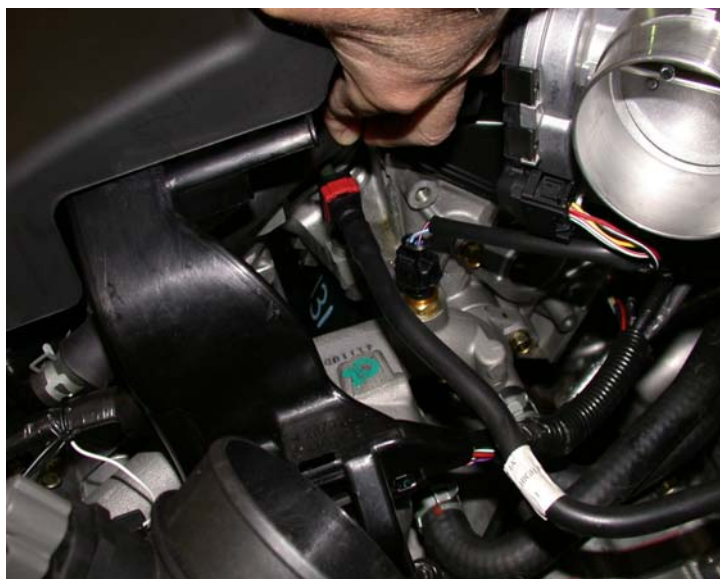
The connector can be accessed by removal of the engine cover and or the air intake hose.
