Recall Notification

MITSUBISHI
MOTORS

No. 010041

SUBJECT: Rectification of L/H rear fuel tank strap bracket – Mitsubishi 380

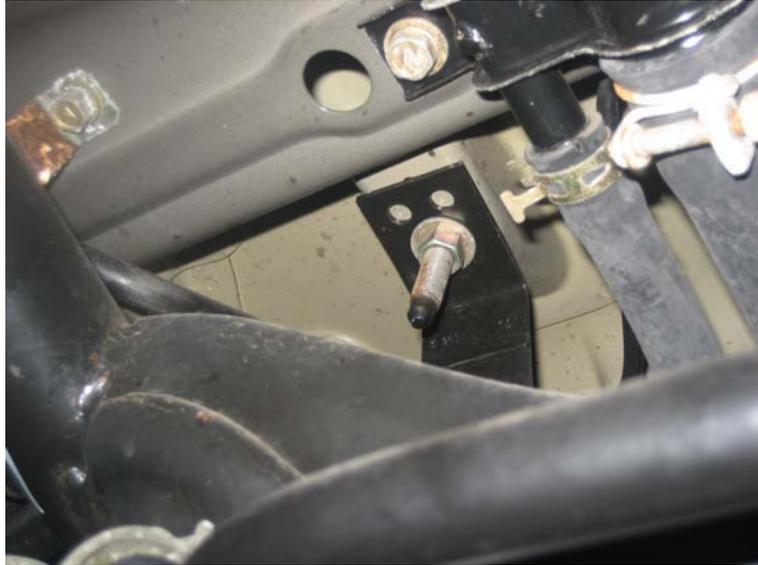
- Raise the vehicle to gain access to the fuel tank mounting brackets
- Locate the rear mounting bracket for the L/H fuel tank strap

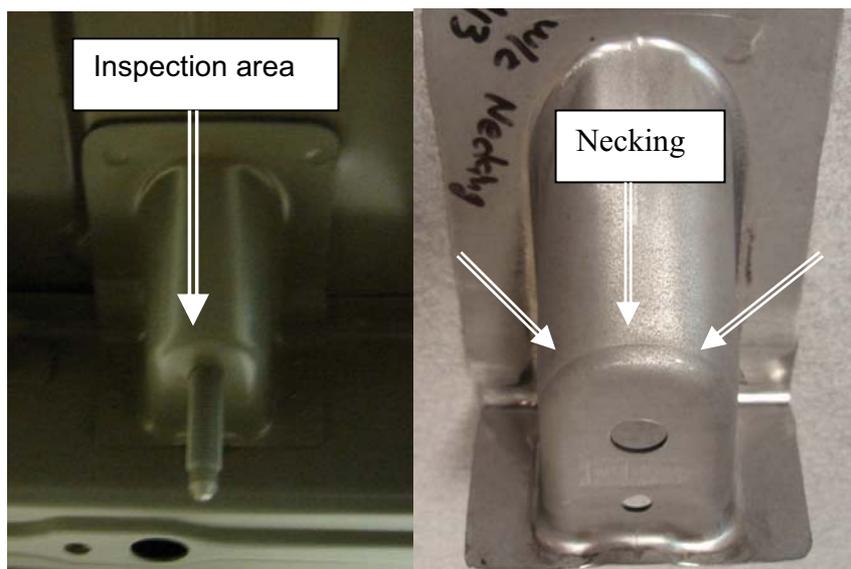
- Lubricate the stud threads then remove the nut that secures the left rear fuel tank strap to the bracket.
- Loosen but do not remove the nut for the front fuel tank strap.
- Remove the tank strap from the rear bracket and clean all debris to allow for inspection (flashlight and a mirror may be required).
- Inspect the front side of the rear bracket for necking or cracking.
- Refer to illustrations below for location of inspection area.

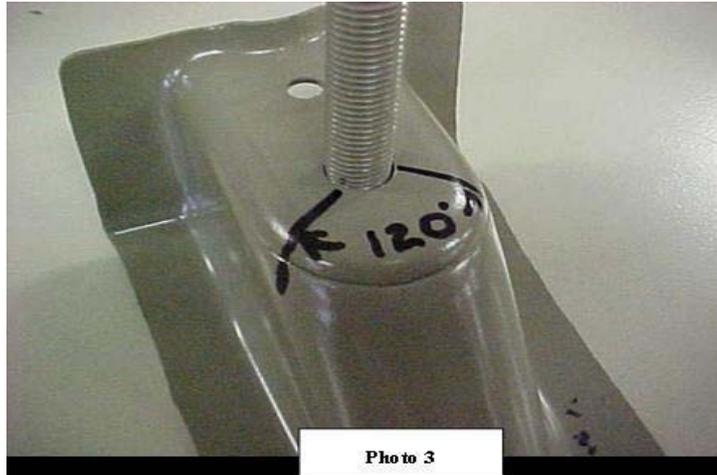
- If no necking of the bracket is observed, reattach the tank strap and retorque both nuts to 26 ± 4 Nm. Inspection is completed.
- If necking is detected, determine if it exceeds the 120 degrees as shown in Photo 3.

- If necking is less than 120 degrees reattach the tank strap and retorque the nuts to 26 ± 4 Nm. Inspection is completed.
- If necking exceeds 120 degrees proceed to repair with the following instructions.
- If cracking is evident proceed to repair with the following instructions.
